# DREDGED MATERIAL RESEARCH PROGRAM

TECHNICAL REPORT D-78-33

## HABITAT DEVELOPMENT FIELD INVESTIGATIONS, PORT ST. JOE SEAGRASS DEMONSTRATION SITE PORT ST. JOE, FLORIDA SUMMARY REPORT

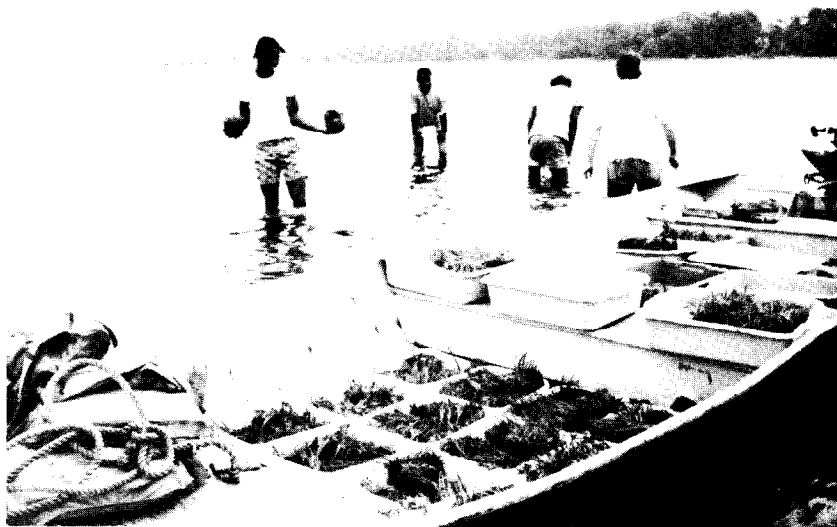
Figure 4. Plugs of shoal grass being removed and placed on boat for transfer to the planting site

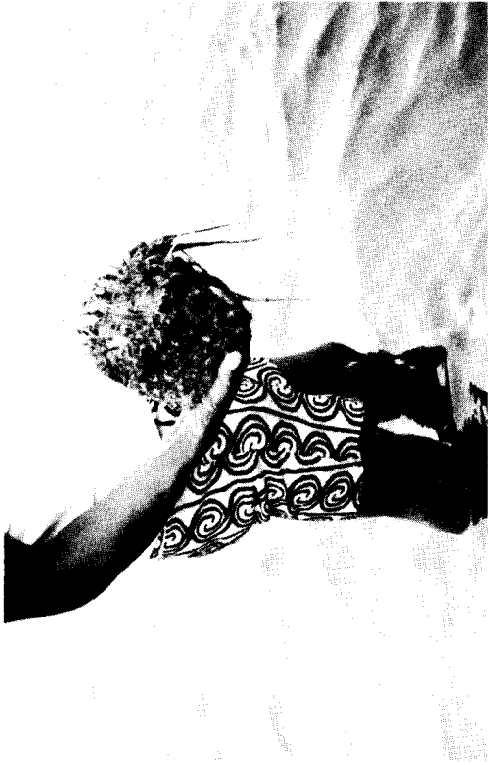
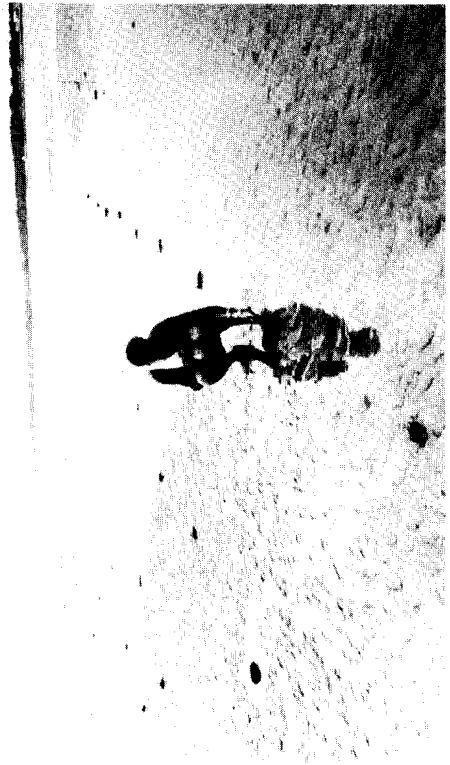
Figure 5. Steps in the planting procedure

a. PVC coring device being used to remove plugs of shoal grass

b. Plugs of shoal grass for transplanting onto dredged material substrate

c. Plugs being planted into sandy dredged material

d. Inspection of plants planted on 3-ft centers

23. Two different sizes and shapes of coring devices were used to obtain the 1488 plugs. For the 1242 smaller plugs ( $177 \text{ cm}^2$ ), a cylindrical 15-cm polyvinyl pipe, constructed at WES, was used. The 246 larger plugs ( $375 \text{ cm}^2$ ) were removed with a 15- by 25-cm iron frame rectangular corer. The rectangular corer was constructed by the senior author; the design was based on a similar device described by Ranwell et al. (1974). During coring, a shovel was used to carefully slice the plug and surrounding sediment free from the bottom sediment under the corer. The depth of coring by each device was about 15 cm and was sufficient to obtain the entire shoal grass rhizome, which generally grows to only about 7 to 10 cm.

24. Following removal, the plants and original substrate were placed intact in plastic containers and transported by boat to the study plots. At the planting site, holes were dug in the dredged material to accommodate the two sizes of plugs. Figures 4 and 5 show photographs of the planting procedure. It took six men about 53 hours (318 man-hours) to obtain and plant the 1488 plugs. At this rate it is estimated that to plant one hectare with plugs at 0.9-, 1.8-, and 2.7-m spacings would require 2180, 555, and 250 man-hours, respectively.

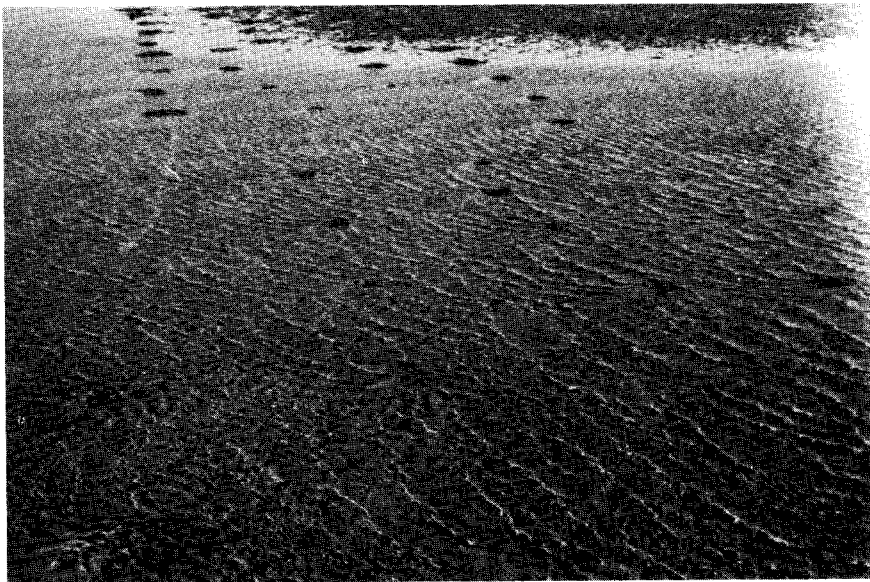
Photo 1. 20 January 1977, plot 1, subplot A  
(0.9-m centers) (sheet 1 of 2)

a. Overview

b. Small Plug ( $177 \text{ cm}^2$ )

c. Large plug (375 cm<sup>2</sup>)

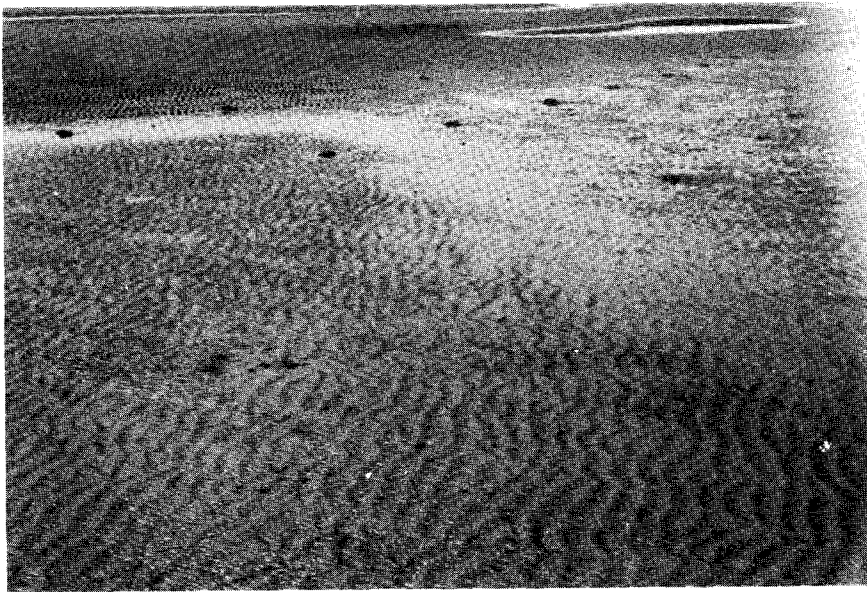
Photo 3. 20 January 1977, plot 1, subplot C  
(2.7-m centers)

a. Overview

b. Small plug ( $177 \text{ cm}^2$ ). Note rhizome extension and plant extension at lower left and right

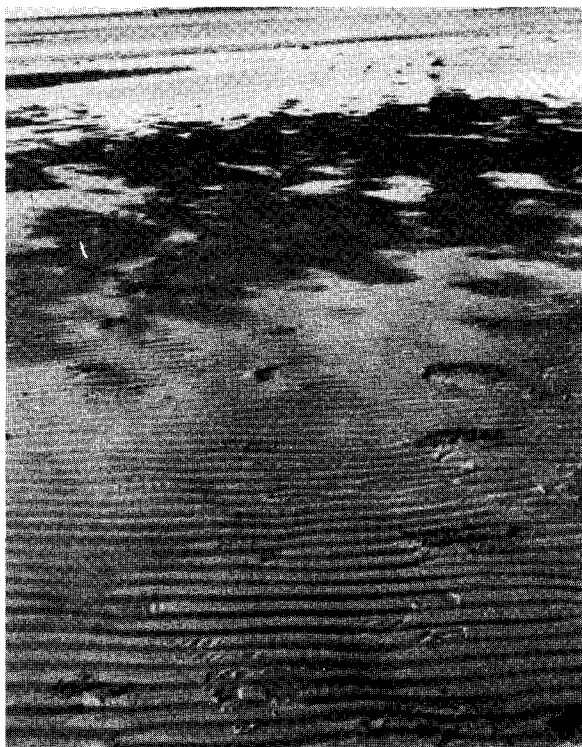
Photo 4. 21 January 1977, plot 2, subplot A  
(0.9-m centers) (sheet 1 of 2)

a. Overview

b. Small plug (177 cm<sup>2</sup>)

c. Small plug ( $177 \text{ cm}^2$ ) showing siltation

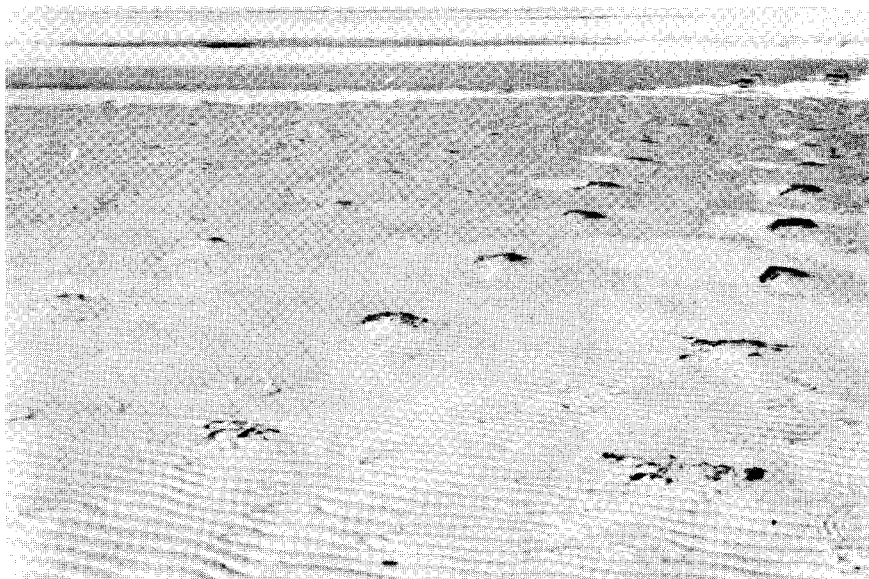
Photo 6. 21 January 1977, plot 2, subplot B  
(1.8-m centers) (sheet 1 of 2)

a. Overview

b. Small plug (177 cm<sup>2</sup>)

c. Large plug ( $375 \text{ cm}^2$ ). Note rhizome extension  
at lower right
